REPAIR, EVALUATION, MAINTENANCE, AND REHABILITATION RESEARCH PROGRAM

TECHNICAL REPORT REMR-CO-3

CASE HISTORIES OF CORPS BREAKWATER AND JETTY STRUCTURES

Report 1 SOUTH PACIFIC DIVISION

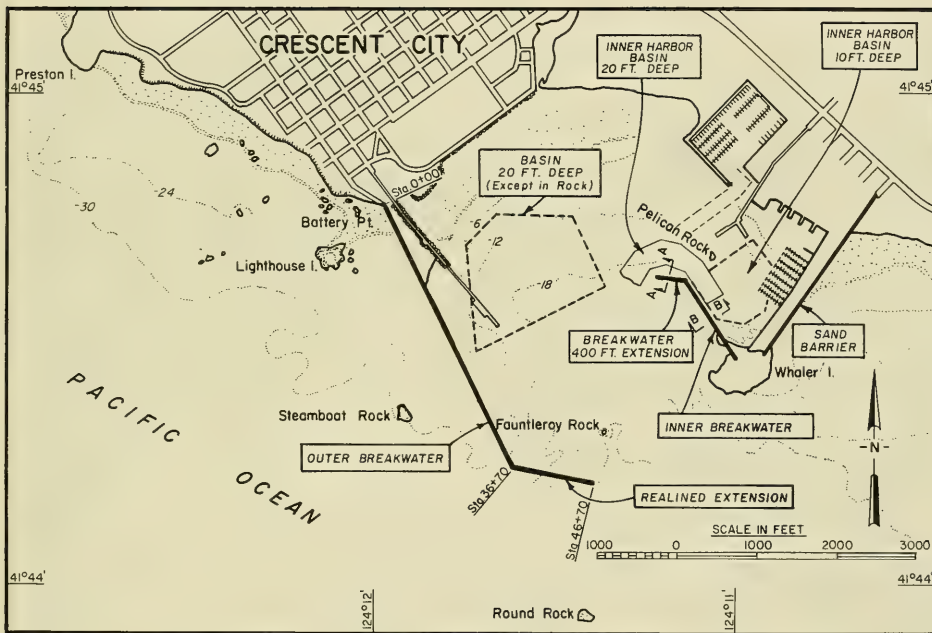
Figure 3. Crescent City Harbor, California

1946	Construction of a 1,200-ft-long inner breakwater was completed to provide protection to a small-craft basin. The inner breakwater extended from Whaler Island northwest (Figure 3). The crest el of the structure was +18 ft mllw (Figure 4) and 10- to 12-ton armor stones were utilized during construction.
1948	A 1,000-ft-long extension of the original (outer) breakwater extending toward Round Rock (Figure 3) was completed. Ten- to 12-ton armor stones were used.
1948- 1949	During storms of 1948 and 1949, the 1,000-ft-long extension of the outer structure suffered considerable damage.
1950	The crest el of the entire outer breakwater, with the exception of a 300-ft segment (sta 12+50 to 15+50), was raised to +20 ft mllw with a 22-ft-wide concrete cap to prevent overtopping.
1950- 1951	Winter storm seasons resulted in further damage to the outer breakwater. Damages consisted of displacement of the concrete cap and armor stones down to about 0.0 mllw in all of the extension located seaward of sta 37+00.

Date(s)	Construction and Rehabilitation History
1957	The 1,000-ft-long outer breakwater extension, as authorized in 1952, was completed. Twelve-ton stone protection was used from sta 36+70 to 41+20. From sta 41+20 to 46+70, 25-ton unreinforced tetrapods (1,836 units) were placed on the seaward slope (Figure 5). Model tests were conducted (US Army Engineer Waterways Experiment Station (WES), Hydraulics Laboratory (HL) 1953, 1956).
1957-1964	Damages occurred to a portion (sta 36+70 to 41+20) of the outer breakwater, and in 1964 were repaired using 12-ton stones and 140 25-ton tetrapods. The tetrapods were not model tested for their adequacy for placement in this area, and they were destroyed over a period of years.
1973	Repairs were made to the concrete cap of the outer breakwater between sta 35+40 and 37+00.
1974	Rehabilitation of the outer breakwater between sta 34+70 to 37+00 was completed. Two layers of 40-ton unreinforced dolosse (246 units) were placed on the seaward slope.

1974	Construction of a 400-ft-long extension of the inner breakwater was completed (Figure 3). Model testing was conducted to determine optimum wave conditions (Senter and Brasfield 1968, Senter 1971).
1979	Repairs were made to the following reaches of the outer breakwater using 18- to 30-ton stone: sta 19+00 to 20+00, 22+00 to 24+00, 24+60 to 27+20, 28+90 to 29+50, 30+50 to 31+00, and 37+00 to 41+20. Repairs to sta 15+50 through 17+50 also were made using stone in the 14- to 25-ton range.
1983	Major storms in the winter of 1983 resulted in broken dolosse on the outer breakwater. Estimated damage to the structures was \$4,400,000.
1984	Approximately 23,300 tons of stone were placed to repair various sections of the outer breakwater between sta 17+30 to 33+90.
1986	The outer breakwater is presently in poor condition. The problem area is primarily between sta 34+70 through 37+00 where missing and/or damaged dolosse are apparent. A contract was issued to rehabilitate the dolosse section of the outer structure (sta 34+70 through 37+00) with 700 fiber-reinforced 42-ton dolosse. The dolos perimeter used special placement, and the dolosse on the outer portion of the seaward transition were entrenched and buttressed with 25-ton stone (Baumgartner, Carver, and Davidson 1985). About 80 of the constructed dolosse were stockpiled on the leeward side of the jetty for repair contingencies. This rehabilitation effort was also used to gather data on prototype forces on dolosse. Twenty of the dolosse (painted red) were instrumented and placed in the main dolos section at about sta 36+00. As of this date, no data have been received from the prototype dolos study.

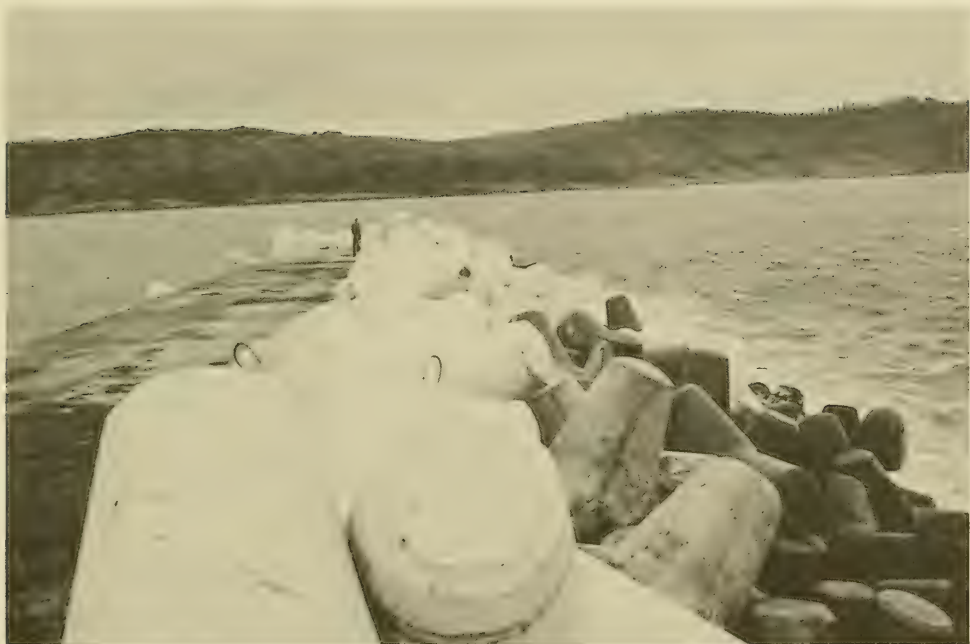
Figure 5. View of tetrapods at head of Crescent City
Harbor outer breakwater

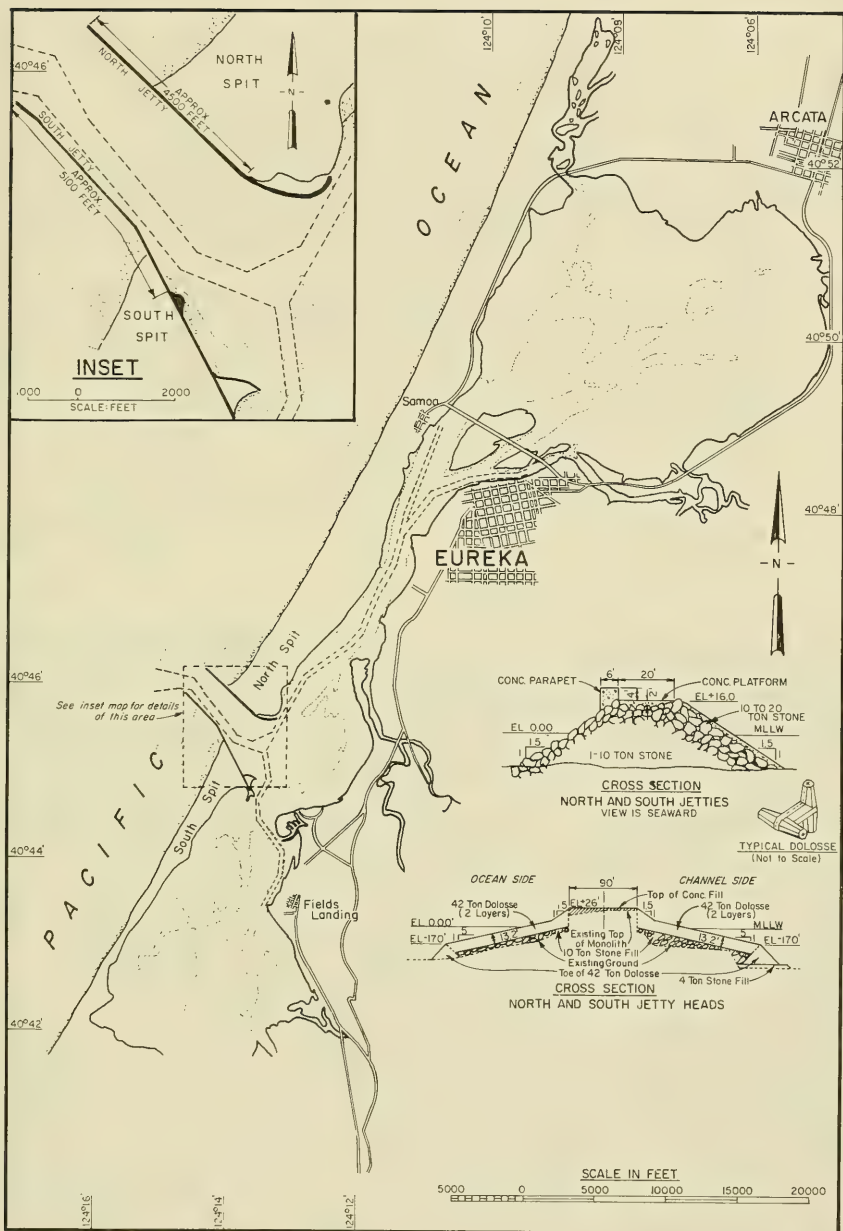
Figure 6. Humboldt Harbor and Bay, California

1937	South jetty repairs using 1,552 cu yd of concrete were completed at a cost of \$25,400.
1939	Heavy storms caused great damage to both jetties. The monoliths at the outer end of the south jetty were undermined, causing them to tilt and sink. Breaches occurred in the jetty immediately shoreward of the monolithic end. A partial breach occurred through the north jetty just shoreward of its monolithic end. In addition, considerable damage was done to the side slopes of both jetties. During the year south jetty repairs were completed using 12,450 cu yd of concrete at a cost of \$151,025.
1940	North jetty repairs using 7,418 cu yd of concrete and 2,200 tons of stone and south jetty repairs using 29,772 cu yd of concrete were completed at a cost of \$311,848.
1941	North jetty repairs using 15,158 cu yd of concrete and 1,705 tons of stone were completed at a cost of \$141,220.
1942	North jetty repairs using 8,809 cu yd of concrete were completed for a cost of \$124,220.

1957- 1958	Severe winter storms deteriorated the north and south jetties to such an extent that repair work constituted a major construction project.
1958	Mass concrete was poured to fill eroded areas on crests, and armor stones were replaced in areas that were breached and washed out. Concrete blocks (11 by 11 ft) weighing 100 tons and 12-ton tetrahedrons were placed on the heads of both jetties.
1959	Major side slope losses on the south sides of both the north and south jetties occurred.
1960- 1963	Rehabilitation of both jetties was accomplished. Jetty trunks were repaired with 12-ton stones placed on 1V:1.5H slopes in the eroded areas. Jetty heads were reconstructed using 20-ton blocks to form head perimeters, and centers were filled with mass concrete. Two-hundred and fifty 100-ton concrete blocks were placed around the seaward tip of the south jetty head. The concrete monolith at

Date(s)	Construction and Rehabilitation History
	seaward end of the north jetty was completed in 1961 and within the year was undermined by wave action resulting in part of the monolith breaking off. The monolith was repaired by placing rocks around the head section on 1V:2H side slopes and grouting the rocks with concrete. The elevation of the concrete at the north jetty was raised to +25 ft mllw and at the south jetty to +26 ft mllw at the tip. The heads were protected with 12-ton stones with a cover layer of 100-ton concrete blocks.
1963-1965	Winter storm waves washed away most of the newly placed 100-ton concrete blocks.
1969-1970	The concrete monolith at south jetty was undermined and broken. Heads of both jetties were totally destroyed.
1971-1972	Rehabilitation of both jetties was completed. Concrete monoliths were reconstructed, and 42-ton dolosse were placed around the seaward quadrant of both jetty heads. Four unreinforced, 1,271 steel-reinforced, and 17 steel-fiber-reinforced dolosse were placed on the north jetty; and 22 unreinforced and 1,423 steel-reinforced dolosse were placed on the south jetty head. Dolosse (43-ton) also were placed on the shoreward transition sections of both jetty heads. Two layers of dolosse were placed using a concentration of 11 dolosse per 1,000 sq ft of slope. Cost of this work was \$10,108,764. Model testing was conducted prior to these repairs (Davidson 1971).

1973	South jetty repairs using concrete and stone were completed at a cost of \$20,400.
1975	An earthquake of 5.2 magnitude on the Richter scale occurred near the site. Inspection trips subsequent to the earthquake revealed fresh cracks along the south jetty running along the edges of the crest and slope for a distance of about 800 ft on the channel side and 300 ft on the seaward side. Blowout holes also were observed at several locations on the south jetty. On the north jetty, three of the dolosse had moved about 50, 100, and 150 ft from the placement area, respectively. Only minor settling of the remaining dolosse had occurred, and no cracking or unraveling of the dolosse units was apparent.
1977	South jetty repairs using concrete and rock were completed. Approximately 15,000 tons of stone ranging from 1 to 20 tons were used for these repairs.
1977-1978	The jetties were subjected to severe storms combined with high tides and winds. On occasion, waves covered both jetties over their entire lengths. Waves also were observed breaking over the dolosse and concrete monoliths of the jetty heads. North jetty repairs using stone were completed at a cost of \$450,000.

Date(s)	Construction and Rehabilitation History
1978	An inspection revealed that the north jetty slope was eroded at several locations, and 12 blowout holes were apparent in the concrete cap. Also, at the north jetty head, waves had broken away a 20-ton concrete block from the concrete monolith which washed across the monolith and was resting against a tip of a dolos. The slope of the south jetty had eroded in numerous locations, and the parapet wall had broken at four stations. Nineteen blowout holes were observed in the south jetty concrete cap. Also a 7-ft stone had broken out of the parapet wall and was deposited on the concrete cap.
1983	Major storms resulted in an estimated \$2,000,000 in damages to the jetties.
1984	Repair of the south jetty consisting of 4,900 tons of 15- to 25-ton stones and replacement of 20-ton concrete blocks at the jetty head was completed. Also 16,665 tons of 15- to 25-ton stones and 16,665 tons of 18- to 31-ton stones were stockpiled on the harbor side of the jetty.

1985	Repair of the jetty heads was completed using a total of approximately 1,000 42-ton dolosse in various areas and the construction of toe berms.

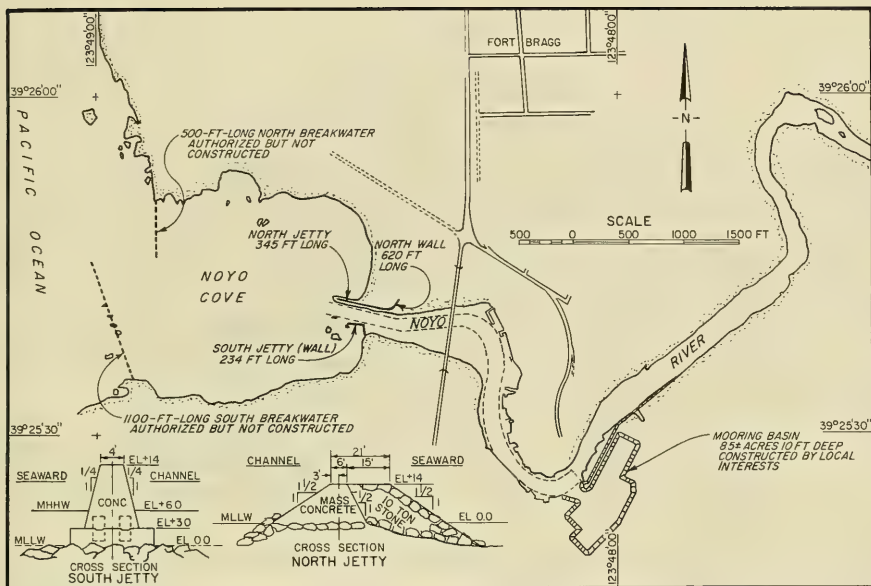
Figure 7. Noyo River and Harbor, California

<u>Date(s)</u>	<u>Construction and Rehabilitation History</u>
1924	Construction of two jetties across a sand bar was completed at the mouth of Noyo River. These were rubble-mound structures spaced approximately 125 ft apart. The initial lengths of the north and south jetties were 648 and 110 ft, respectively.
1931	Work at the Noyo River entrance, which included dredging, rock removal, and reconstruction of the jetties, was completed. The jetties were constructed to their present lengths (Figure 7). The north jetty was constructed of mass concrete. It was 345 ft long and connected to a 620-ft-long concrete wall. The south jetty was constructed 234 ft long with concrete. Both structures had crest els of +14 ft mllw.
1945	A 1,100-ft-long outer rubble-mound south breakwater was authorized (Figure 7). This structure has not been constructed.
1954	Stone (10-ton) was added to the seaward side of the north breakwater (Figures 7 and 8).

1961	Minor rehabilitation of the jetties and north wall was completed.
1962	A 500-ft-long outer rubble-mound north breakwater was authorized (Figure 7). This structure has not been constructed.
1970	The two outer breakwaters authorized by the Acts of 1945 and 1962 were reclassified from an active to inactive category. They were not economically feasible because of the high cost of construction and maintenance. Model testing of the structures was conducted (Wilson 1967).
1983	Restoration of the north jetty head was completed. Materials used consisted of approximately 2,500 tons of capstone, 10 cu yd of concrete, 1,500 cu yd of sandfill, and 4,100 tons of quarystone fill.
1986	The jetties are presently in good condition. Model testing currently is being conducted to optimize the location of a structure in the immediate area of the River entrance (Bottin, in preparation).

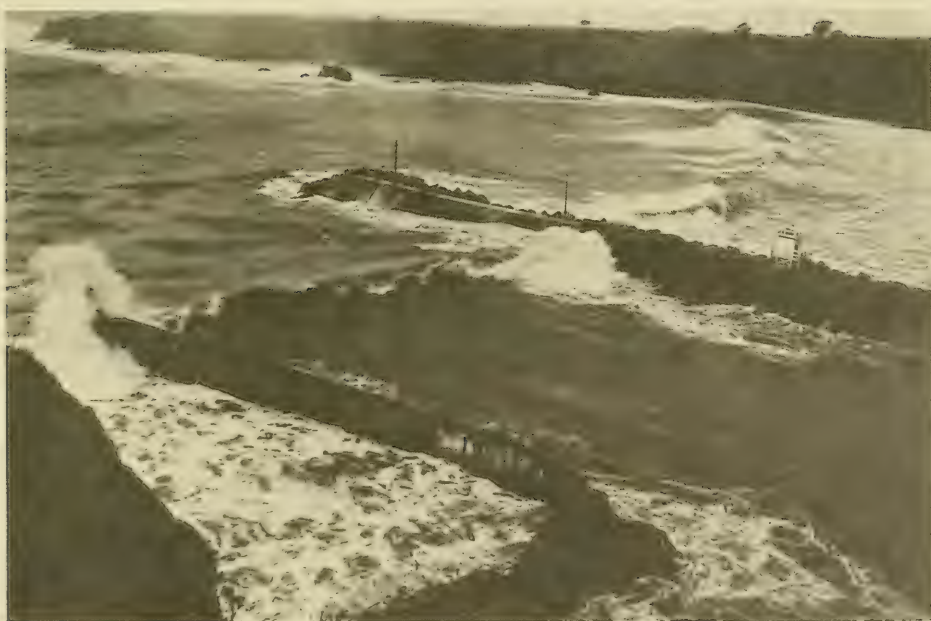
Figure 8. View of the jetties at Noyo River entrance

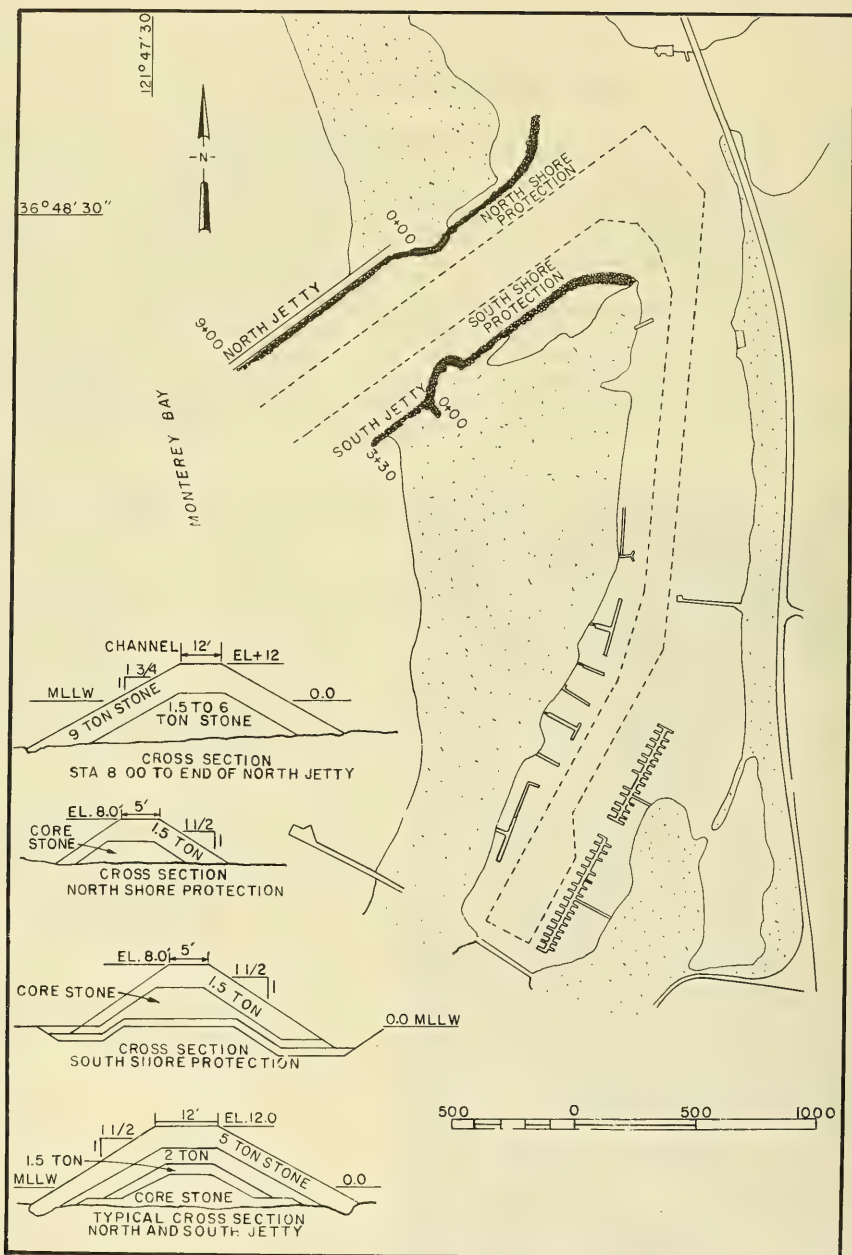
Figure 19. Moss Landing Harbor, California

1949- 1965	Severe erosion around the jetties and the unprotected shorelines adjacent to them was experienced during this time frame.
1966- 1967	Approximately 285 ft of the north jetty and the entire length of the south jetty were repaired. Also about 280 ft of curved revetment work was added to the north jetty and about 380 ft added to the south jetty. This work required the placement of 77,560 tons of stone. The north jetty head was not repaired because of the movement of the canyon head and the possibility that damage may occur to any repairs in that vicinity.
1975	A field inspection revealed the jetties in satisfactory condition except for damage on the seaward ends due to erosion and subsequent stone displacement. The deep submarine canyon head at the seaward end of the north jetty appeared to have stabilized.
1976	A basis for design of repairs to the jetties and revetment was prepared. Estimated cost of these repairs was \$290,000, and approximately 7,400 tons of stone would be required.

1986	Work is still required at the jetty heads. Except for the erosion at these locations, the jetties historically have performed satisfactorily and suffered relatively minor damages.

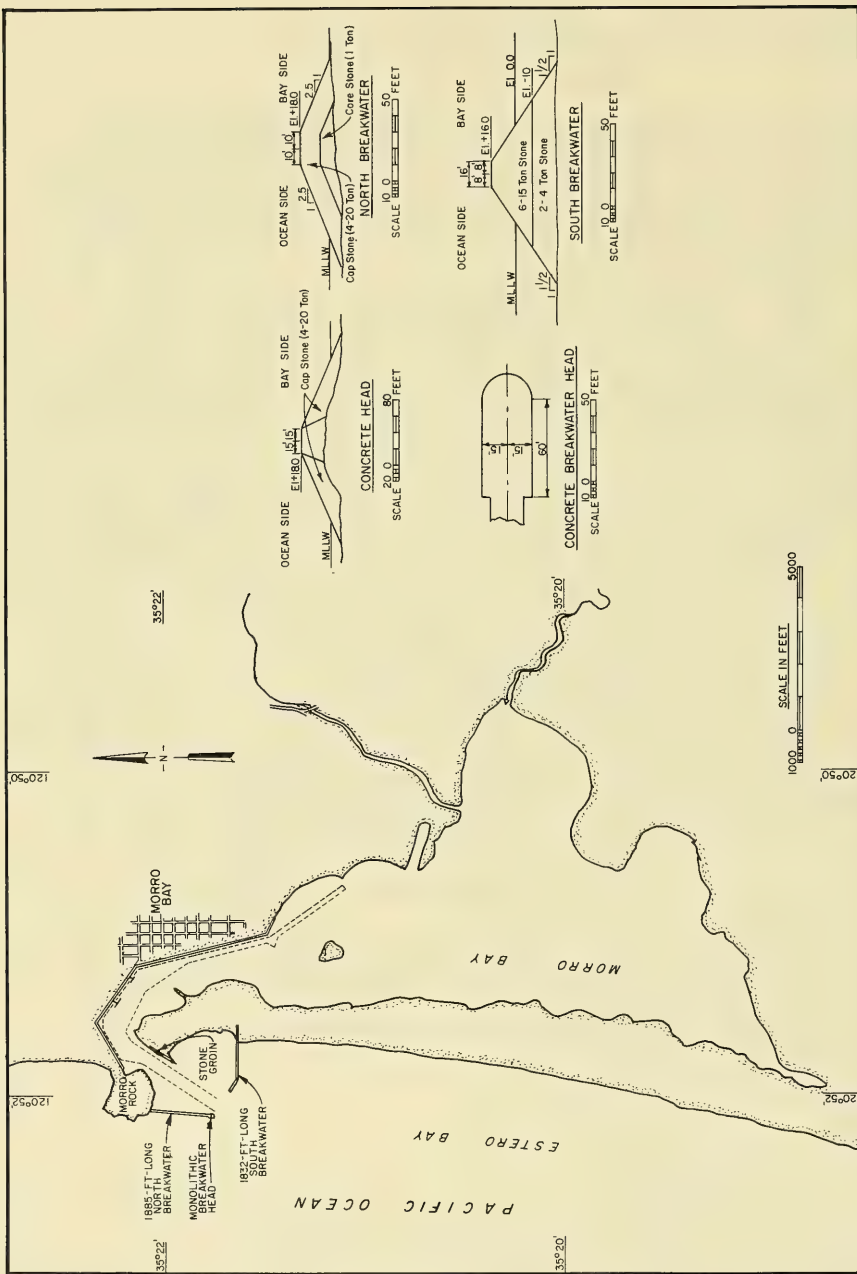
Figure 21. Morro Bay Harbor, California

Date(s)	Construction and Rehabilitation History
1942	A 1,000-ft-long north breakwater was constructed, and a 1,832-ft-long south breakwater was completed at the site (Figure 21) to serve as a base for naval patrol craft. The structures were rubble-mound and built at an el of +16 ft mllw with 1V:1.5H side slopes and a crest width of 16 ft.
1943	
1943- 1944	Storm waves during this period damaged the north breakwater. The south breakwater received no appreciable damage.
1945	The north breakwater was repaired and extended to 1,800 ft in length. This work also included widening the crest from 16 to 20 ft. The project was adopted and completed under the supervision of the CE using funds provided by the US Navy.
1946	The north breakwater again suffered damage from storm waves.
1948	Maintenance work was performed on the north breakwater. Damaged sections of the structure were restored, and the cap was bound with concrete across the crest to an el of -2 ft mllw on both sides.

1949- 1960	The north breakwater continued to deteriorate, and shoaling occurred in the channels. The south breakwater still had suffered no observable damage since its construction in 1943.
1964	The north breakwater was reconstructed at a cost of \$1,561,882. The new rubble-mound structure was built at an el of +18 ft mllw, with a 20-ft-wide crest and 1V:2.5H side slopes. The structure was rebuilt about 100 ft bayward of the original north breakwater location and extended to 1,885 ft in length (Figure 21). The breakwater included larger armor stone than the original structure. Also included was a concrete monolithic breakwater head. Model tests were conducted (Jackson 1961).
1983	Major storms resulted in approximately \$1,430,000 in damages to the breakwaters.
1985	Maintenance repair of the north and south breakwaters was completed which included the placement of approximately 18,000 tons of capstone. Capstones ranged in weight from 6-21 tons each.

1986	The structures presently are in good condition.

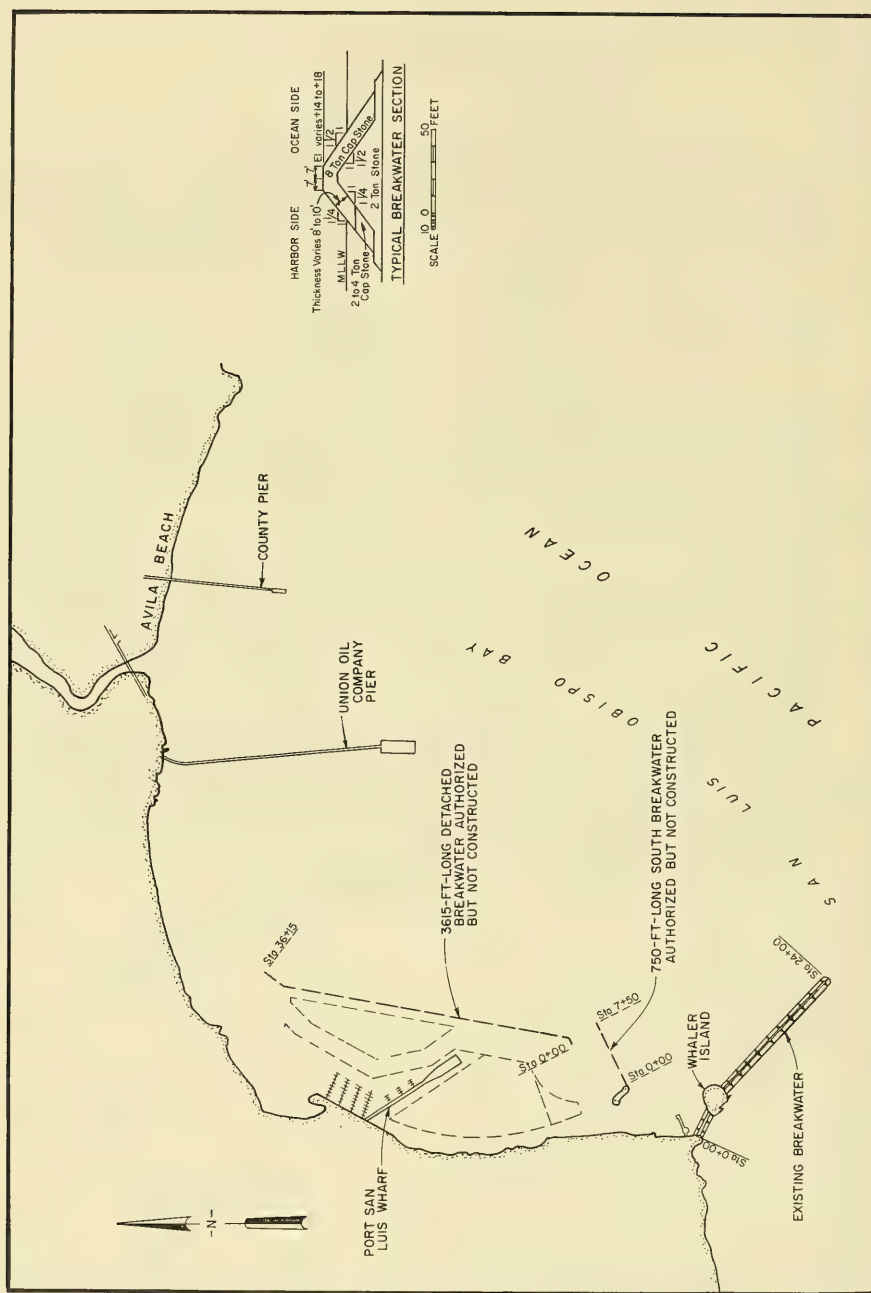
Figure 22. Port San Luis, California

<u>Date(s)</u>	<u>Construction and Rehabilitation History</u>
1888-1913	Construction of a rubble-mound breakwater, approximately 2,400 ft long, was completed at the site (Figure 22) during this time frame. The crest el of the structure varies from +14 ft to +18 ft mllw with a 14-ft width. The side slopes are 1V:1.5H on the ocean side and 1V:1.25H on the harbor side.
1924	The structure was breached in a zone about 300 ft seaward of Whalers Island (Figure 22) by storm waves.
1927	The breach formed in 1924 was filled with a concrete cap.
1931	The concrete cap placed in 1927 was washed away because of storm wave activity. Also, the head of the breakwater was damaged.
1935	Repairs were made to damaged areas of the structure. The slopes in the damaged zones were covered with 14-ton stones to els of -10 to -15 ft mllw.
1976	Modification of the existing project was authorized. Included were a 750-ft-long south breakwater, a 3,615-ft-long detached breakwater, and dredging of associated channels and anchorage areas (Figure 22). These structures have not been constructed.

1983	Major storms resulted in approximately \$578,000 in damages to the breakwater.
1984	Maintenance repair of the existing breakwater was completed which consisted of approximately 8,700 tons of capstone placement and resetting of 40 existing capstone. The crest width of the structure was increased to 20 ft. Plans and specifications for construction of the modified project (authorized in 1976) were about 80 percent complete.
1986	The breakwater currently is in satisfactory condition.

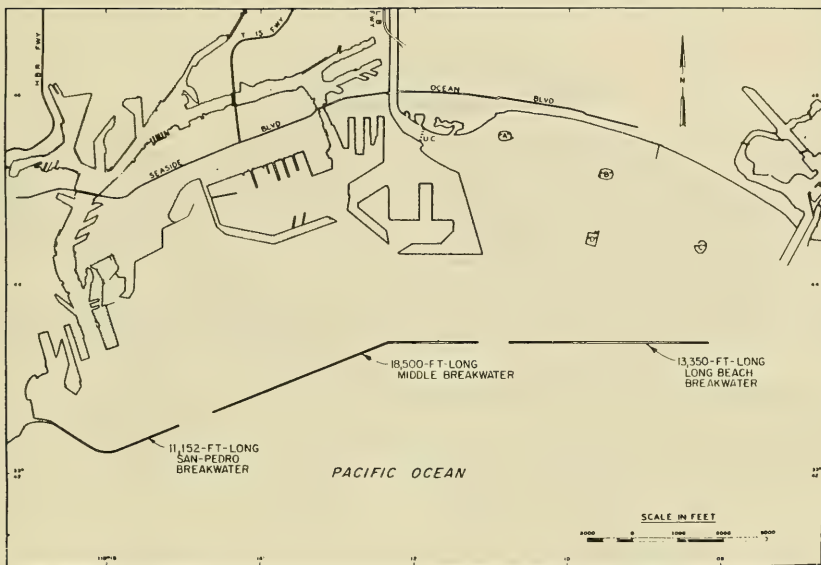
Figure 29. Los Angeles and Long Beach Harbors, California

1942- 1960	Construction of the 13,350-ft-long rubble-mound Long Beach Breakwater (Figure 29) occurred during this period. With the exception of the breakwater core el (Figure 30) the cross section of this structure was similar to that of the middle breakwater.
1947	Repairs to the middle breakwater were accomplished for a cost of \$786,700.
1983	Winter storms resulted in extensive damage to the San Pedro Breakwater. The structure was breached in an area immediately seaward of the curved portion of the breakwater. Model tests were conducted after the damage (Carver 1984, Baumgartner, et al. 1986), and restoration of the San Pedro Breakwater was subsequently completed. Work consisted of the placement of approximately 25,000 tons of salvage stone and new angular stones ranging from 15 to 25 tons each. Where voids occurred on the crest after this stone placement, concrete was pumped into flexible temporary forms to complete the repair.

1986	The breakwaters presently are in good condition.
